Geophysical Investigation of Road Failure in Federal College of Education (Technical) Asaba, Delta State, Nigeria Using Electrical Resistivity Imaging (ERI) Method

Published Date: 30-April-2026

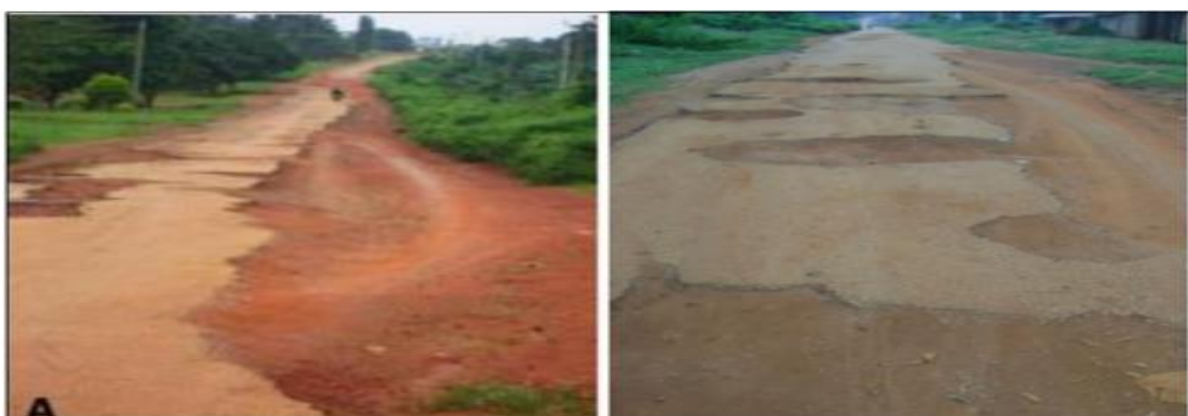
Fig.2: Failure portions of the Road segment identified at Federal College of Education (Technical), Asaba, Delta State.

. Secondly, lack of proper drainage system which may cause gutter not to drain away excess water on the surface of the roads also increases the moisture content of the clay underneath the asphalt. This causes the Asphalt to cave in, causing the cracks and the potholes on the road surfaces observed. These findings corroborate earlier geotechnical observations that clay-rich and water-saturated layers are the dominant contributors to pavement instability in the study area.

This paper therefore recommends that the engineers should endeavor to excavate at least 2m of the top soil and fill them with a more competent material such as laterite (red soil) to ensure good bedrock or foundation. More importantly, that proper drainage system should be constructed on both sides of the roads to avoid road pavement failure and finally that construction engineers should endeavor to carry out proper ERI geophysical surveys before road construction to avoid pavement failure.

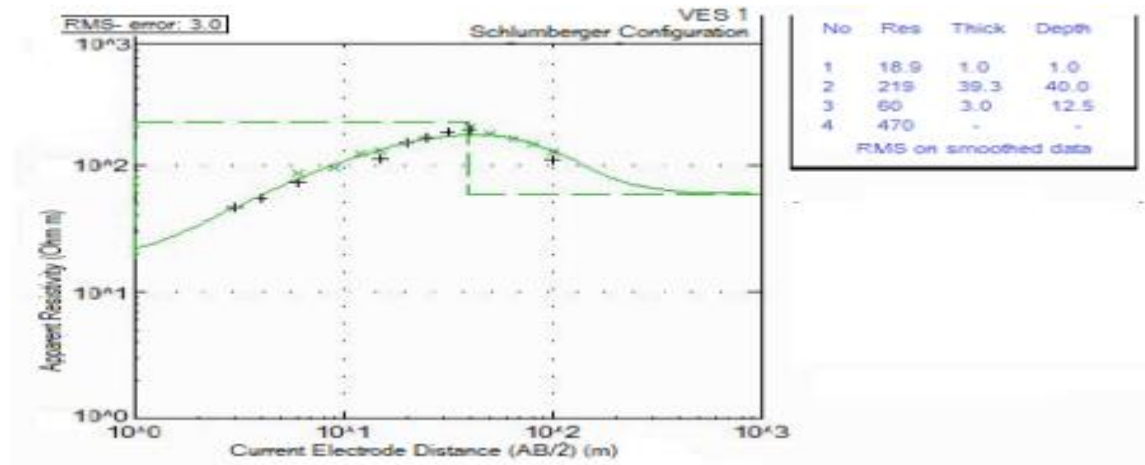
Fig 2: Sample of sounding curve for VES 1

The electrical resistivity data acquired were interpreted, and the results were displayed as 2-D pseudo-sections and sounding curves (Figure 2) along with their corresponding models. From the result, four to five geo-electric layers were delineated, which is topsoil, lateritic, clayey/silty, and weathered basement/high resistivity (Table 1). The resistivity, which indicated incompetent geologic material colors and competent geologic material colors, is shown on the pseudo sections as blue representing very poor rocks, green representing poor rocks, yellow representing fair rocks, red representing good rocks, and purple representing very good rocks. The first layer is made up of topsoil (clayey sandy), which has resistivity ranging from 50 Ωm to 300 Ωm with thickness between 0.5 m and 1.7 m. The resistivity is within that of clayey sandy lithology, which suggests a high moisture content composition.

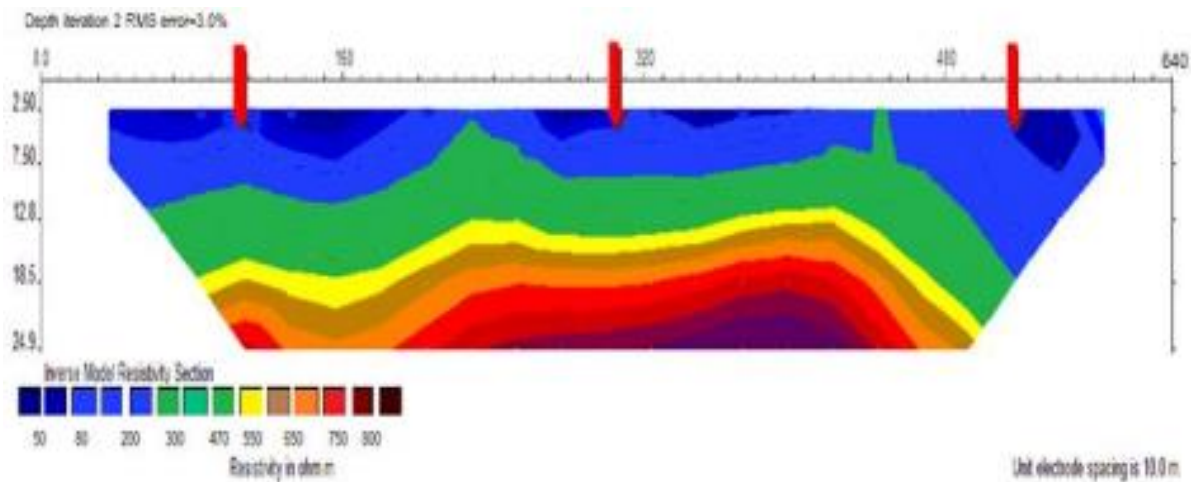
Fig 3. Pseudo-section plot of Lithology Interpretation showing stratified colour layers VES 1, VES 2 and VES for Federal College of Education (Technical), Asaba, road profile. The arrows depicted regions with very low resistivity represented blue colour. The pseudo sections above is computer interpreted iterated inverse model.

The results in VES 1, VES 2, and VES 3 in table 1, represented in the pseudo section in Figure 3, indicate very low resistivities and the presence of a clayey, water-bearing layer with high moisture retention and plasticity at a depth of 5.8 m, which leads to water infiltration, weakening the pavement foundation and leading to progressive structural failure of the road segment in the study area. While VES 4 and VES 5 in Table 1 represented in the pseudo section in Figure 4 exhibit higher resistivities in deeper layers, indicating more competent geologic materials (sandy to lateritic), suitable for supporting road foundations after proper compaction and drainage. These results are consistent with field observations and support the conclusion that high-resistivity zones are suitable for pavement foundations. As a result, for a stable road foundation building in the study area, the topsoil must be excavated at least to the weathered basement competent (competent layer) to avoid road pavement deformation. Hence, any engineering structure built on them will cause differential settlement and instability foundations and possibly lateral deformation under pavement

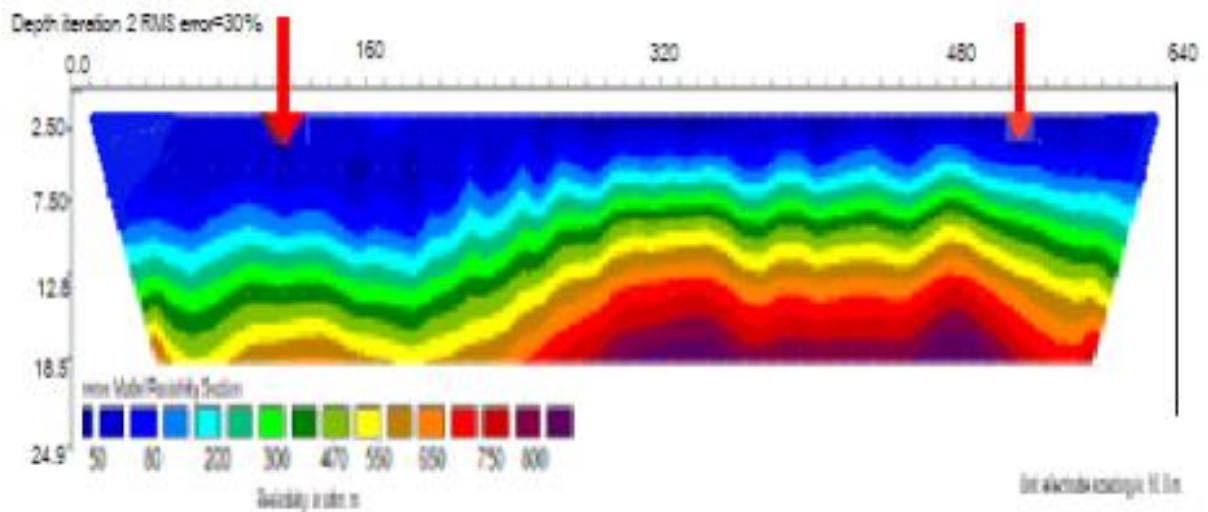
Figure 4. Pseudo-section plot of Lithology Interpretation showing stratified colour layers VES 4 and VES 5 for FCE (T) Asaba road profile. The arrows depicted regions with very low resistivity represented blue colour. The pseudo sections above is computer interpreted iterated inverse model.
