Investigating the Cause of Premature Tyre Failure of Open Pit Mine Dump Trucks: A Case of ABC Mine, Northeast Africa

Dr. Dyson Galatia, PhD

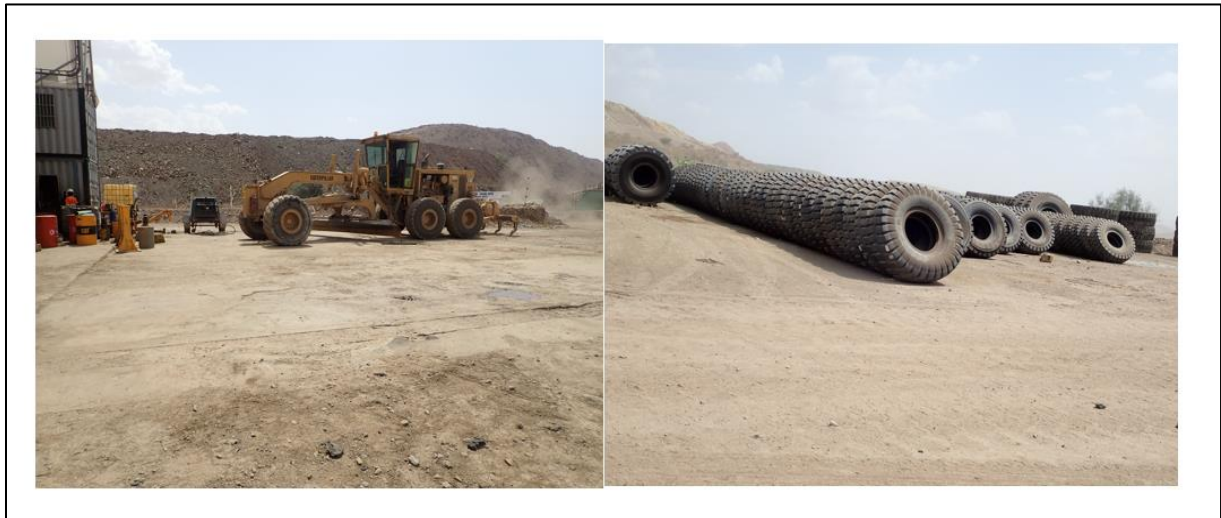
Figure 11: Tyre Work Area and Storage Yard

There was no physical tyre workshop at the mine, tyres were changed from an open space in front of the Dump Truck workshop. The signage was not to standard as there was only signs displaying the kind of PPE required within the workshop area, there was no sign related to tyres or tyre safety.

The storage of tyres was not adequate, the tyres were placed in an open space exposed to various environmental conditions such as heat from the sun and water. Stands and chock blocks were of a correct design and adequate in number and all personnel working on tyres had correct PPE. Additionally, the mine had a universal tyre handler which was suitable for all heavy duty tyres on the mine. Figure 11 shows the tyre worksite area.

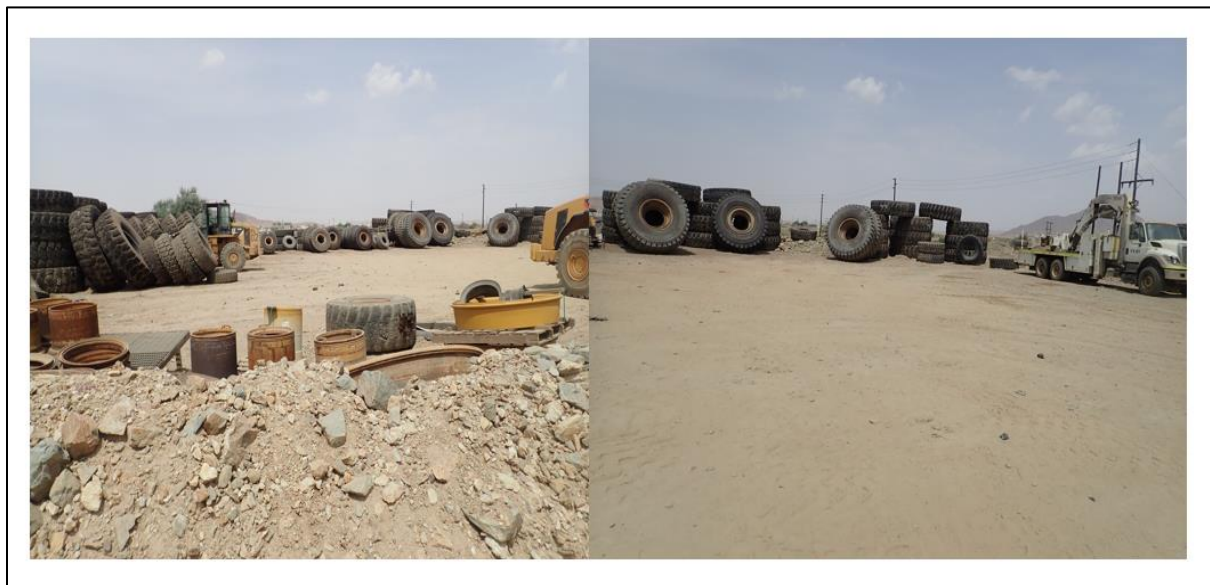
Figure 12: Tyre and Components Storage Area

Further, the tyres were not segregated according to their condition, there were only two areas of new tyres and failed or worn-out tyres. Figure 12 shows the tyre and components storage areas. These are assembled, worn-out and damaged tyres as well as tyre components.

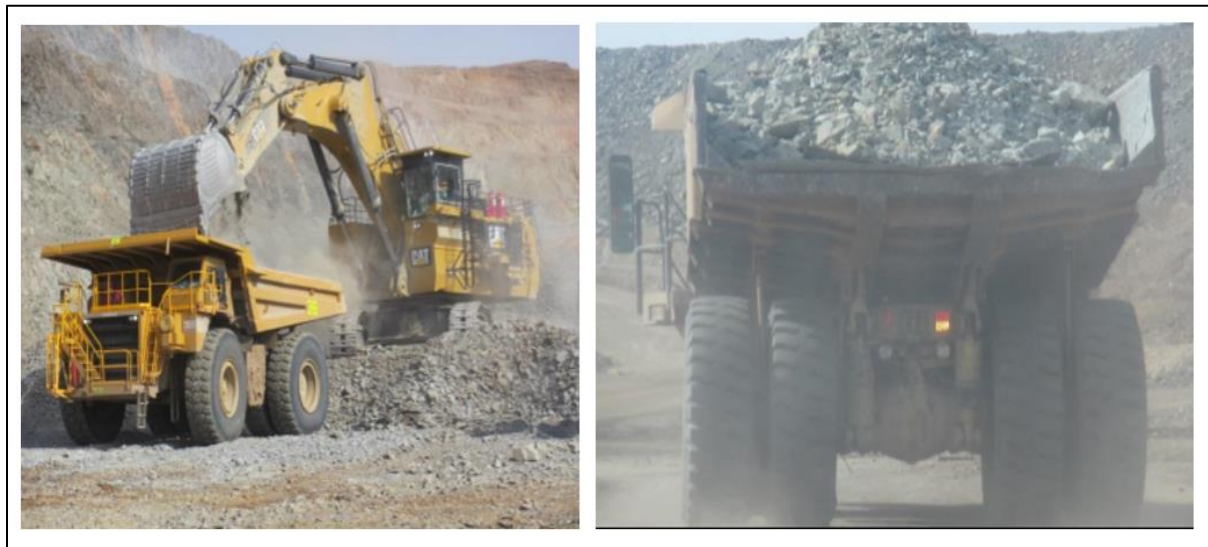
Figure 13: Truck Loading

- i. Spillage – loose gravel ranging from 5mm to 35mm
- ii. Undulation – active undulated ground
- iii. Payload distribution – load along center of the machine and concentrated to the front of the machine
- iv. Loading point layout – moderately wide loading area. However, it requires the machine to reverse and maneuver
- v. Surface condition – dry
- vi. Size of surface material – aggregate 5 – 50mm

Figure 13 shows the loading area with a Dump Truck being loaded and a Loaded Truck heading for the tipping point.

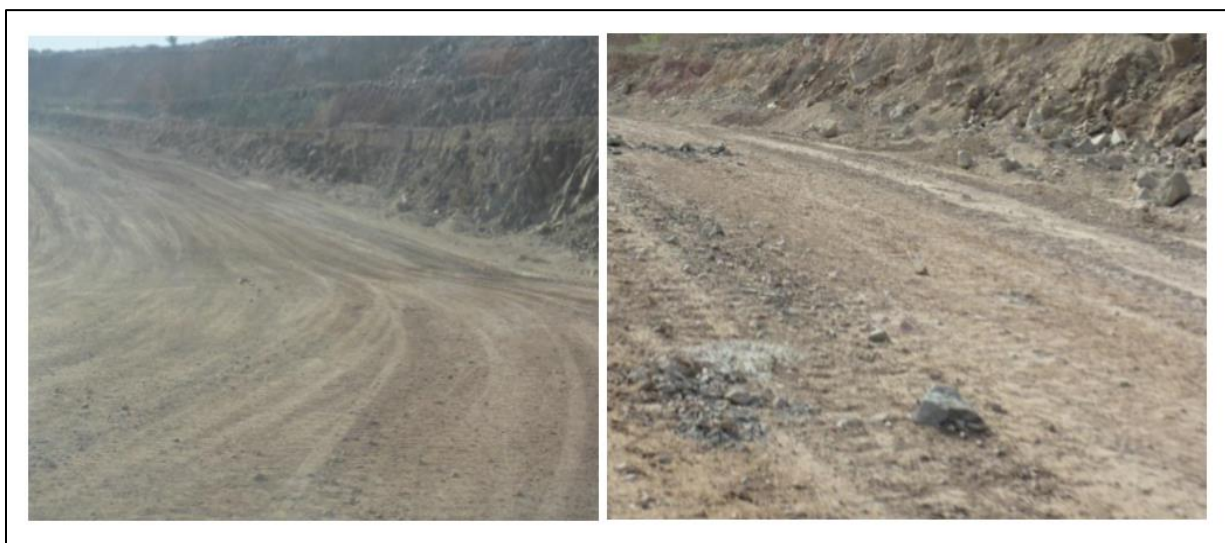
Figure 14: Road condition

- i. Width – the majority of the roads were wide with few tight corners
- ii. Spillage – noted, moderate to high risk of tyre cuts and aggression
- iii. Undulation – low to moderate
- iv. Sharp turns – two (2) sharp turns were observed on the road
- v. Water – not significant, reasonably dry
- vi. Size of surface material 5 – 50mm

Figure 14 shows the condition of the roadways.

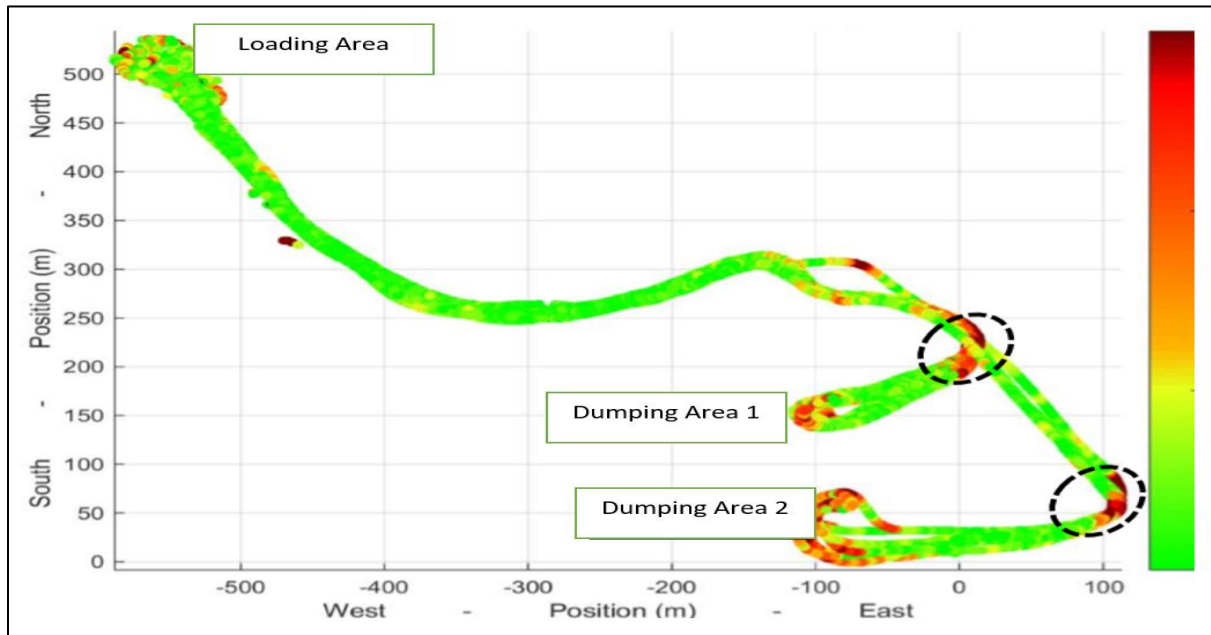
Figure 15: Haulage Route

The two tight turns were observed near the two dumping points, however, operators were encouraged to reduce speed as they approached these two areas. Figure 15 shows the location of the two sharp turns.

Lateral acceleration was observed in a number of areas more especially around the turns to the dumping area. Lateral acceleration is the force that ‘throws’ a moving vehicle sideways during a turn. Table 1 shows the curve radius against the Truck speed along the route shown in Figure 15.

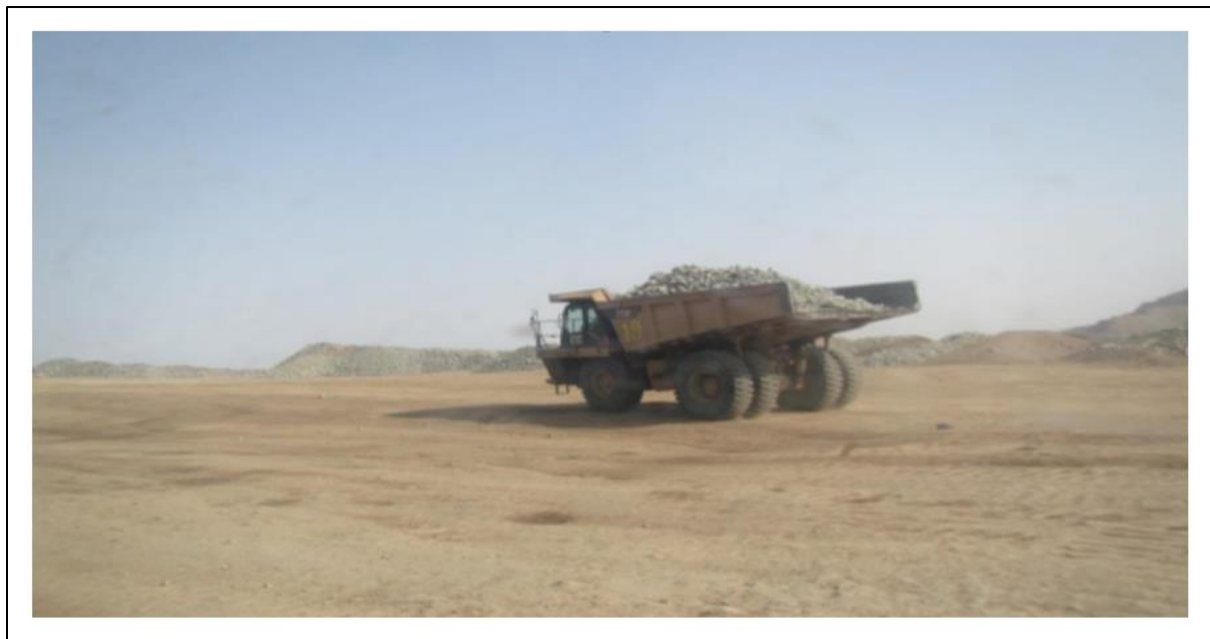
Figure 16: Dumping Area

- i. Spillage – low to moderate
- ii. Undulation – frequent undulation, hard compacted surface
- iii. Water – dry surface

Figure 16 shows a loaded Truck around the unloading area.

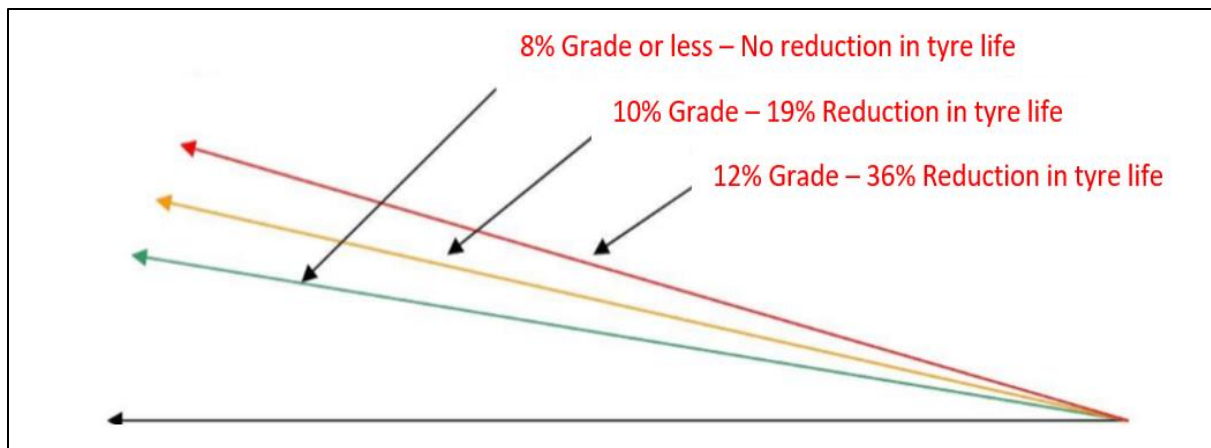
Figure 17: Tyre Wear Rate

The route did not have major slopes, though in certain areas the maximum downhill reached 10%. Figure 17 shows the deterioration of a tyre due to slope effect.

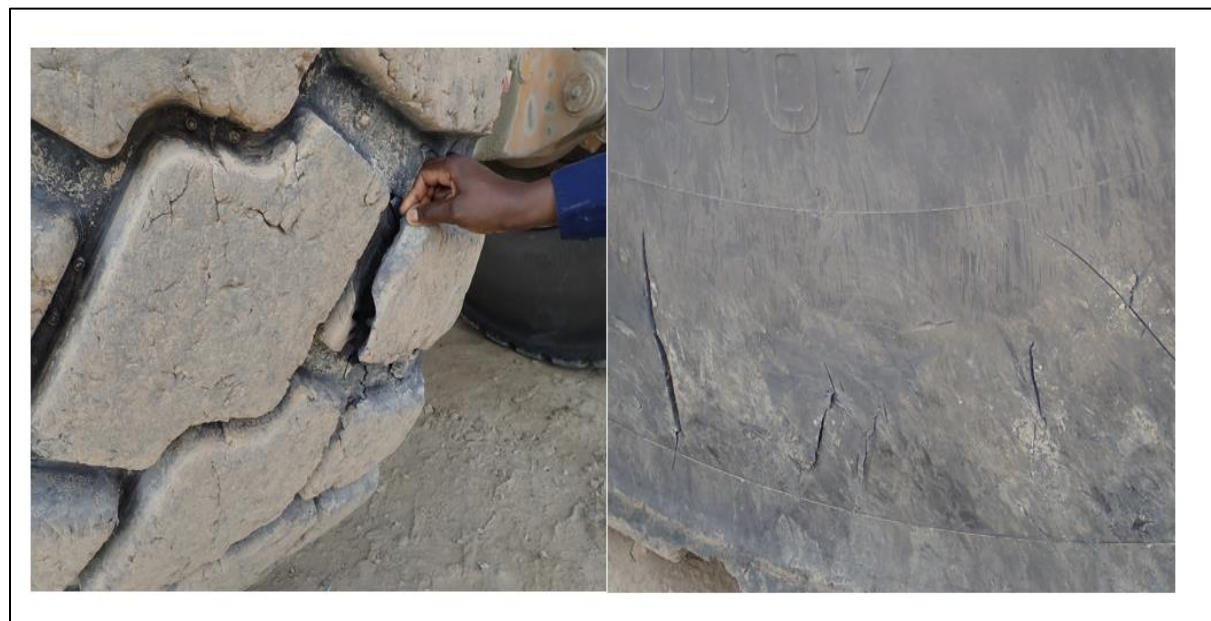
Figure 18: Tyres on a Dump Truck

The condition of tyres, both on the machine and dismantled were observed to determine the nature of failure and the possible failure cause. Figure 18 shows the condition of two separate tyres on a Truck.

The cracks were not sustained from any sharp object, but developed while the machine was in service. This was common to all CAT789B Trucks investigated and a lot of rubber pieces from tyres were noted along the haulage route. Figure 19 shows some of the failed tyres with respective operated hours.

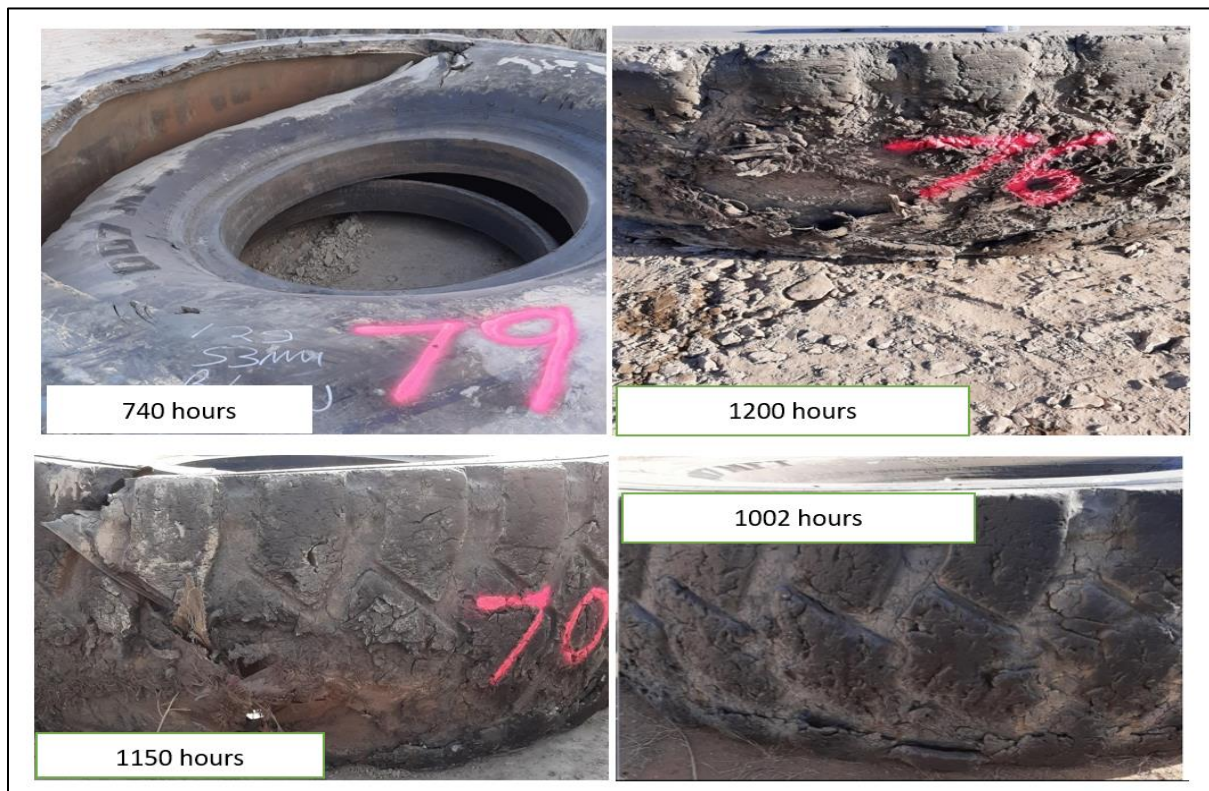
Figure 19: Tyres Failure Modes

Figure 19 shows some of the failure modes observed, a number of tyres failed in a similar ways at low operating hours. Three (3) blow outs were experienced with no injury to personnel, however, from two incidents, nearby equipment was damaged, a Dozer and an Excavator, both lost side windows.
