MAPPING AND MONITORING OF THE IMPACT OF GULLY EROSION IN THE DISTRICT OF MEDINIPUR (WEST), WEST BENGAL, INDIA

Dr. Subhendu Ghosh

Abstract: Gully is generally said to be a channel developed by extended rainfall. It is a common form of soil erosion in the lateritic highland of Medinipur(West) District in the state of West Bengal. It also causes siltation and sedimentation in the River Kansai and Silaboti catchments area. The erosion of the subsoil reduces soil productivity and the continuous extension of gully in the monsoon season threatens roads building, trees, etc. The magnitudes of this erosion depend on infiltration, slope pattern, shear stress for erosion, vegetation cover and as well as anthropogenic factor related to the this area. Deforestation on highland region and other areas increases the rate of erosion in a very rapid rate. The physical landscape is changing rapidly and at the same time cultural landscape is also affected with the advancement of gully in agricultural land, forested land and also other useful land. The focus of this research project is therefore on gully erosion and its impact western and north western part of the district. The natural causes of gull

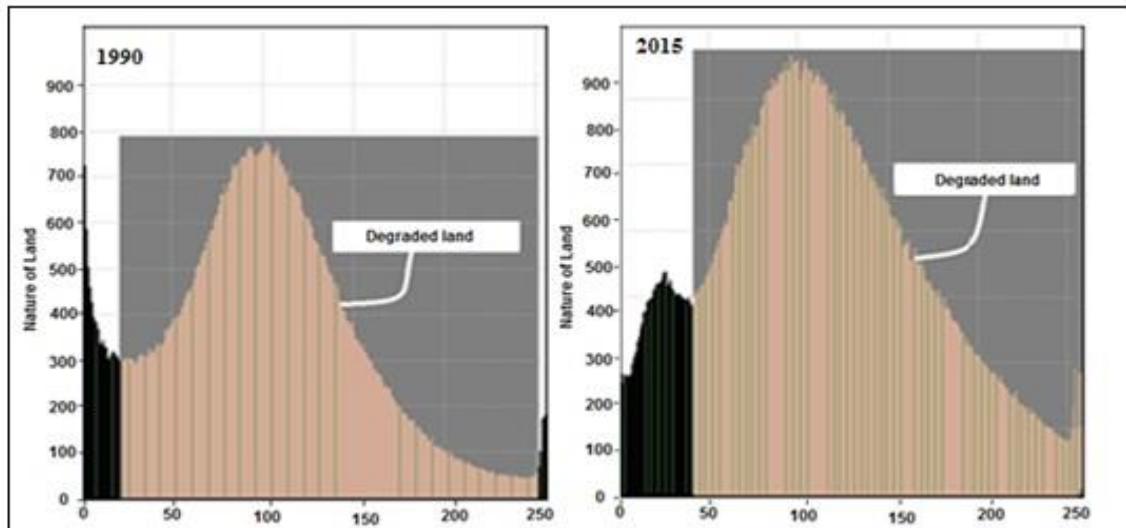
Figure-4: DN analysis of near infrared band of Landsat TM shows the change of degradation characters during 1990-2015

To measure the landscape the landscape change the author has prepared two different FCC maps of different year using the Landsat -TM image which shows the landscape change of degradation or conversion of land from good land to badland during 1990 to 2015. The maps show that the gully has more deepened and extended in 2015 (Figures -4 & 5).

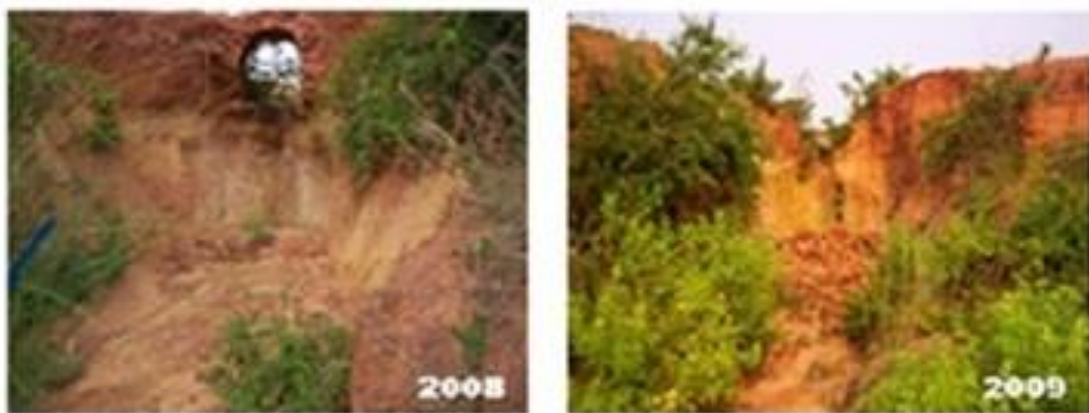
Plate-1: Change of landscape by gully erosion

In Rangamati gully basin along Kangshabati the erosion towards gully head is observed very high due to massive erosion by overland flow retreating every rainy season. The major linking roads in the areas have been virtually destroyed in many portions or completely cut off in Rangamati gully basin (Plate -1).

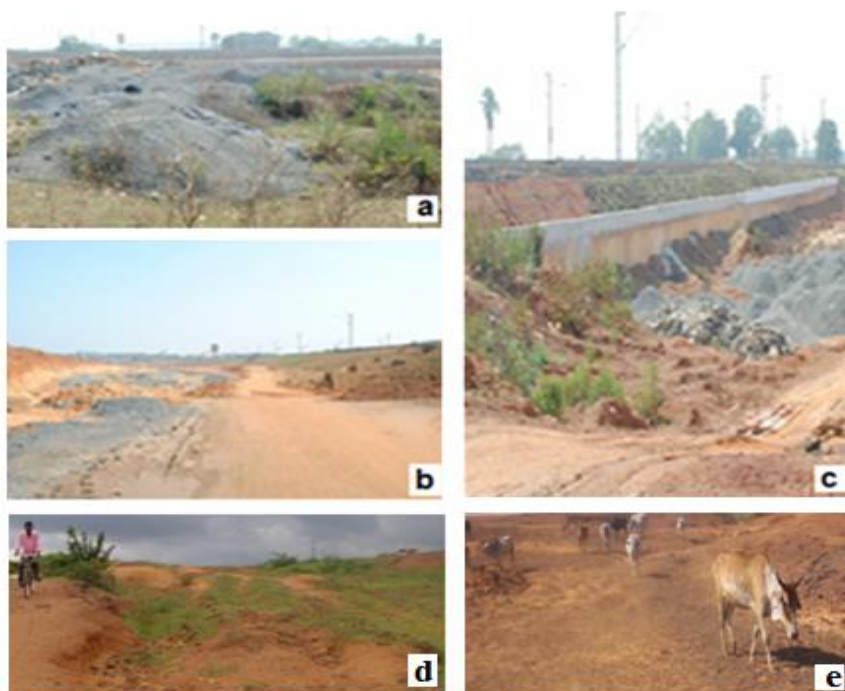
Plate-2: Photographs (a, b, c,d & e) showing human activities on the Gully landscape in the study area

Cracking of house, falling of buildings and trees and damage of roads into gully sites are common features in the erosion-prone areas of Paschim Medinipur District. Grazing (Plate-2) is a very common human activity which raises the Probability of erosion in the study area. Construction of houses, roads and railways by cutting and filling the gully sites of Rangamati (Plate-2) is increasing day by day to serve the increasing population.

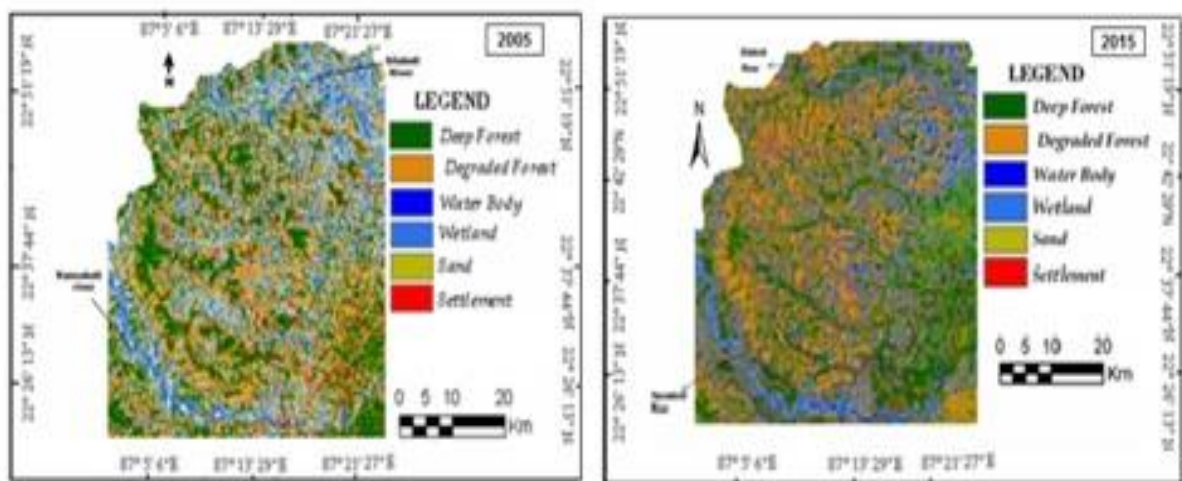
Figure-9: Land use and land cover maps of the badlands environs of the study area during 2005 and 2015

Land-use and land-cover map of the study area have been prepared from Landsat TM image of different years in 2000 and 2010 respectively. In 2000 degraded forest was less due to more coverage of vegetation. This map has shown erosion which has taken place in the northern bank of Kangsabati River and in the southern bank of Silabati River. But, It has been seen in the map of 2015 that the degradation of land is higher than 2005. The major eroded part is lying in between the Silabati and Kangsabati River. Due to continuous degradation of forest gully and rill erosion are getting wider and rapid headword extension of gully has degraded forest land also (Figure-8, 9)

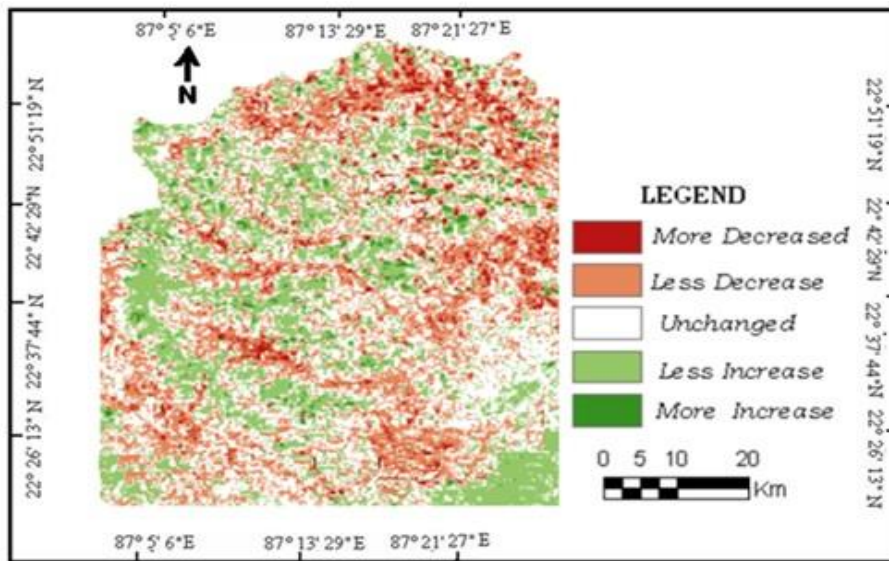
Figure-10: Change Detection map of the badlands environ of the study area

A change detection map has been prepared on the basis of vegetation, soil and also other parameter considered. In this map it is clearly revealed that the study area has changed in a large scale. In between the Silabati River in the north to Kangsabati River in the south including Garbeta, Salboni Jhargram and Medinipur where the maximum change has been seen in this map. Change in vegetation is high in term of loss of vegetation cover which indicates that soil erosion in this area is increasing rapidly. The legend shown in the map is represented in terms of decrease and increase of special change generated by erosion and other human activities like deforestation, farming and constructional activities (Figure-10)

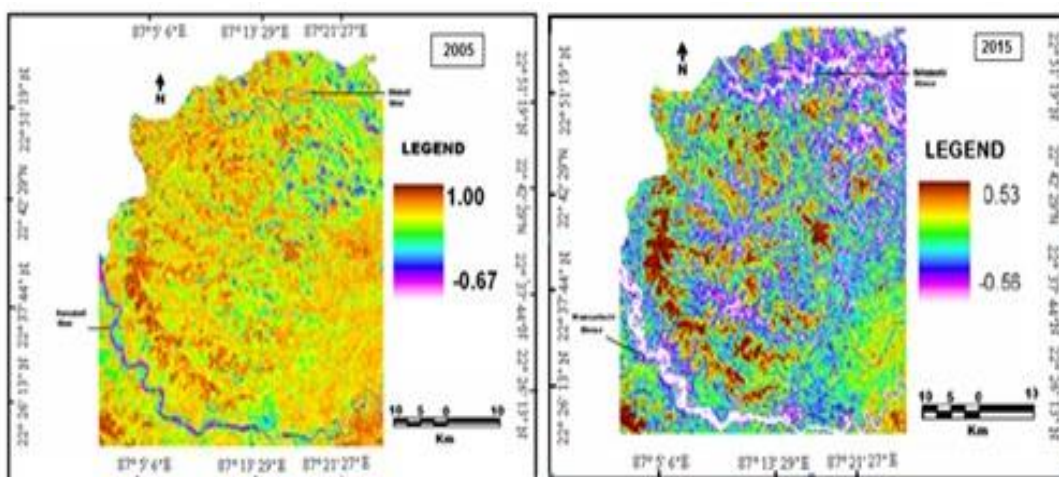
Figure-11: NDVI Map (2005 & 2015) of the badlands environ of the study area

NDVI is calculated from the visible and near-infrared light reflected by vegetation. Healthy absorbs most of the visible light that hits it, and reflects a large portion of the near-infrared light. Unhealthy or sparse vegetation reflects more visible light and less near-infrared light (Figure-11).

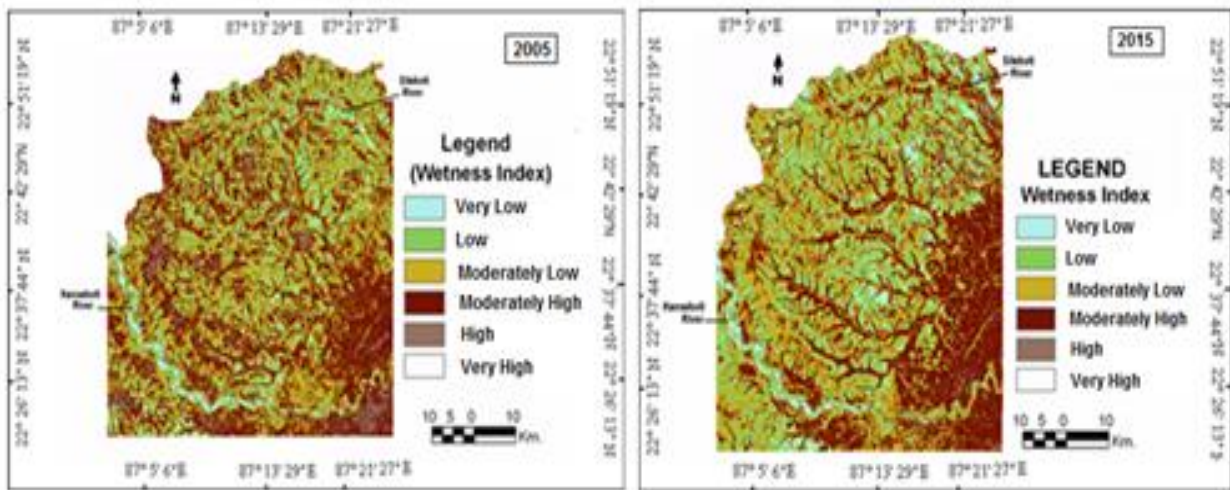
Figure-13: Greenness Vegetation Index (GVI) Map (2005 & 2015) of the badlands environ

Wetness Vegetation Index (W.V.I.) map has been prepared here to understand soil bonding capacity of different location of the study area. Soil bonding capacity is an important factor of soil erosion and for this two different W.B.I. map of different year (2005 and 2015) has been prepared to assume the change particularly the exposition of soil buy gully and rill erosion. In a W.B.I. map the existing soil moisture is an important physical character of soil usually affected on landscape change. The above W.B.I. Map is showing that the higher green vegetation with higher soil moisture indicates the higher soil bonding capacity which helps to resist erosion buy preventing gully or rill formation. But where the lower green vegetation with less soil moisture, erosion is high due to lesser soil bonding capacity Gangani is a very good example of massive gully erosion as a region of less vegetation cover. Same kinds of erosion are also seen at Rangamati and Gopegarh area. But quite less deep and wider forested gully has been found at Salboni and Gurguripal, Lalgargh, Bhadutala for high soil moisture with high soil bonding capacity due to relatively more vegetation cover. In the forest end there has been seen a common formation of relatively shallow gully in the study area which are highly responsible for the destruction forest land especially in the Jhargram gully sites (Plate-4,Figure-12&13)

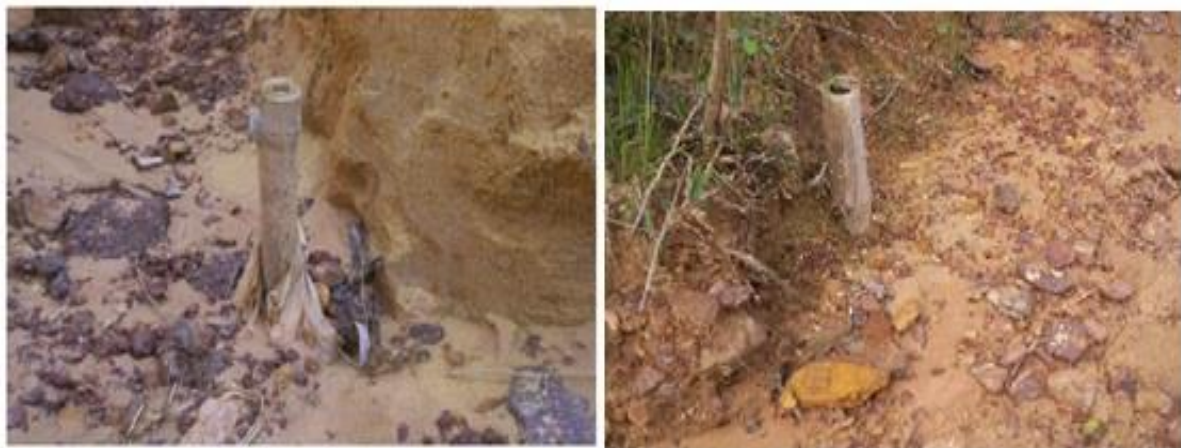
Plate-5: Photographs showing the processes of measurement of deposition on the gully floor at Garhbeta

To measure the loss of top soils and headword extension and deposition in the gully floor some indicator of bamboo has been fixed for demarcation in different points on the gully floor and the gully head (Plate-5). It has very effective in measuring erosion and deposition. The GPS mapping also has been done in to different year for better realization of change in the study area Overland flow erodes and transports soil from slopes to the gullies in the study areas, which efficiently flush the eroded material out of the local system. This process has serious impacts for soil quality and inherent soil fertility. Natural top soils contain soil organic matter from the trees, bush and grass vegetation, that are recycled by future vegetation growth and support the biodiversity of the ecosystem. The removal of top soils from the exposed soil surfaces leads to a reduction of soil fertility. The author has experimented on some soil sample which has been collected along the gully and also across the gully in different year to measure the change of soil status in the study area (Table-3).

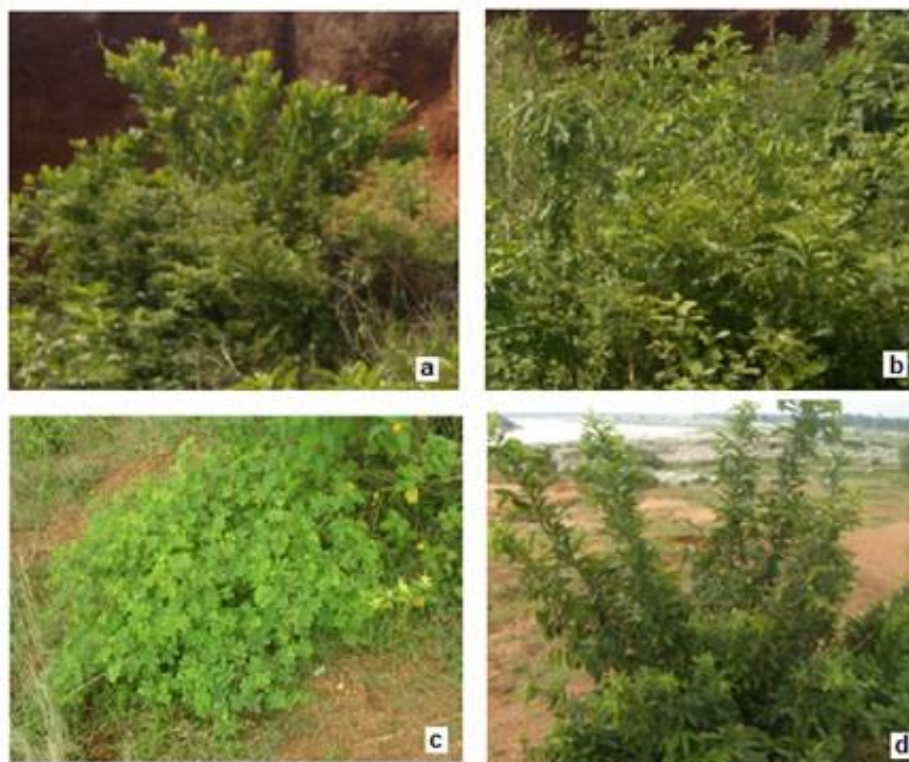
Plate-6: Photograph showing the common species of the study are

The study area has experienced tropical deciduous species. The very common species is Sal grown in the major parts of this area. This area is covered predominantly with Sal of coppice origin on an average 60% area is covered with Sal and the rest is covered with plantation, scrub jungles and bushes. These forests occur in disjointed patches of varying sizes and in many instances an island among cultivation fields and habitation. The usual associates of Sal in this region are Pterocarpus marsupium, Madhuca latifolia, Schleicheria olosa, Terminalia arjuna, Terminalia belerica, Bombax ceiba etc. Plantation mostly includes Eucalyptus, Akashmoni, Bamboo and Kaju etc. For proper management of the forests the following Working Circles are adopted Besides this species like Mahul But the surveyed parts are a poor coverage of vegetation. The badlands of different parts of the study area have experienced only some shrubs and bushes in spite of some plantation species like casuarinas, and eucalyptus (Table- 2.&Plate-6).

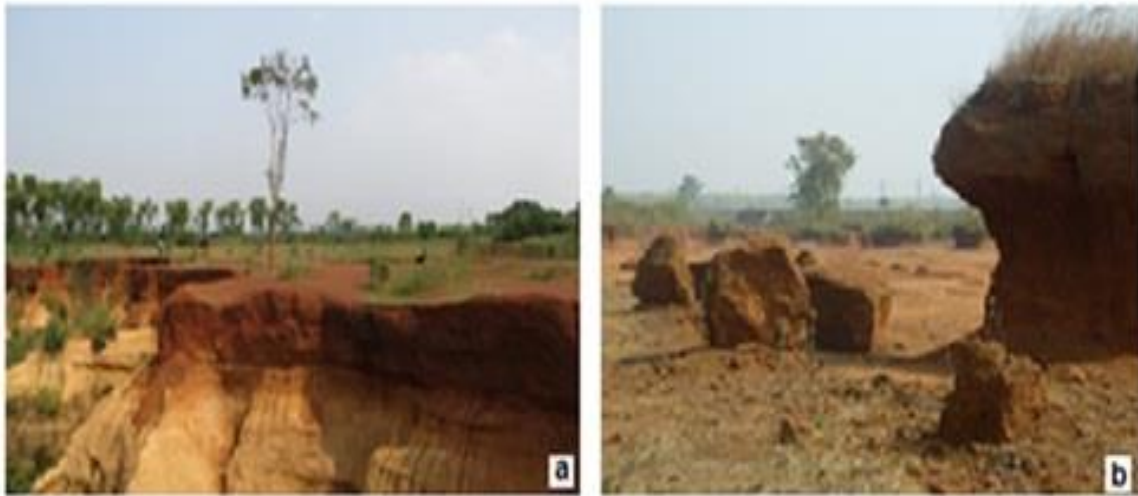
Plate-7 a) extension of gully towards plantation land at southern bank of Silabati river, b) Weathering in a laterite mining area near Godapiasal railway station.
