# The Potential of Soil Properties in the Stability of Buildings a Case Study of Collapsed Building in Kwang Jos, Nigeria

Nigerian Building and Road Research Institute (NBBRI) North Central Zonal Office Jos, Plateau State, Nigeria  
(Federal Ministry of Science, Technology and Innovation)

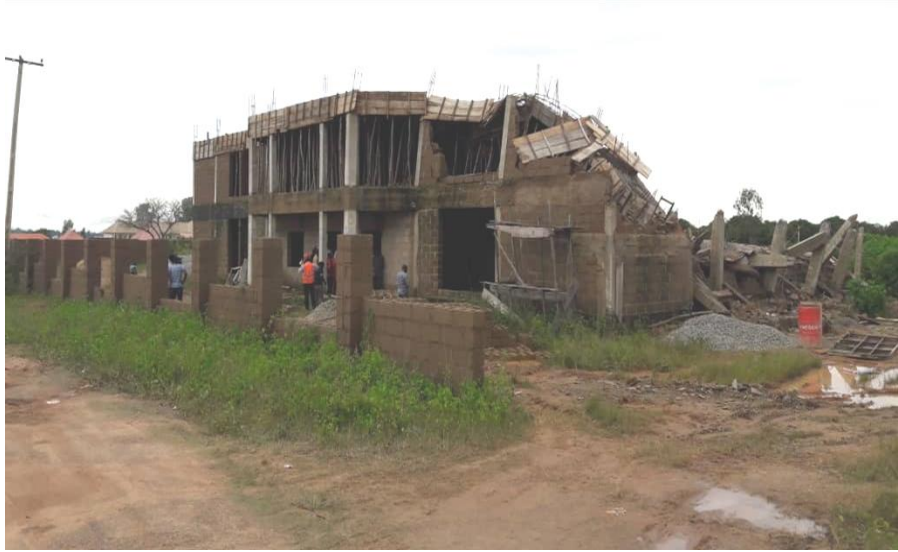
**Plate 1: Inspection of the Collapsed Building and Physical Survey of the Soil**

The soil encountered in this site is very soft and silt concentrated obviously by physical observation. This shows that the site is suspected to be a made-up ground possibly from an originally covered mine pit which has not been properly reclaimed and has led to mass movement underground, resulting in the voluntary collapse of the whole building.

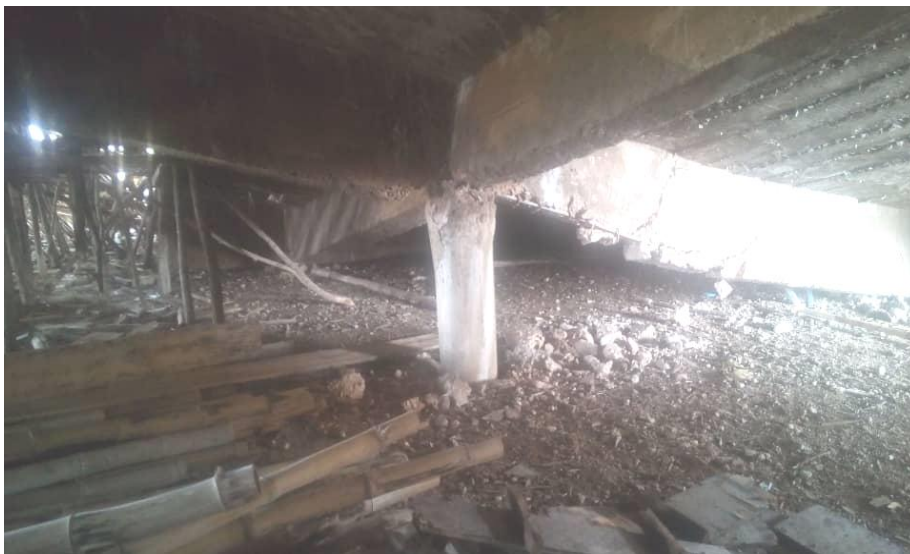
**Plate 2: Inner Portion of the Collapsed Building showing a sunken column**

A sunken circular column was discovered in the collapsed building, penetrating some feet down into the ground as further evidence to the fact that near the whole site was an improperly reclaimed abandon mine pit, possibly from the activities of Tin mining done a long time ago.
