Investigating the Cause of Premature Tyre Failure of Open Pit Mine Dump Trucks: A Case of ABC Mine, Northeast Africa

Dr. Dyson Galatia, PhD

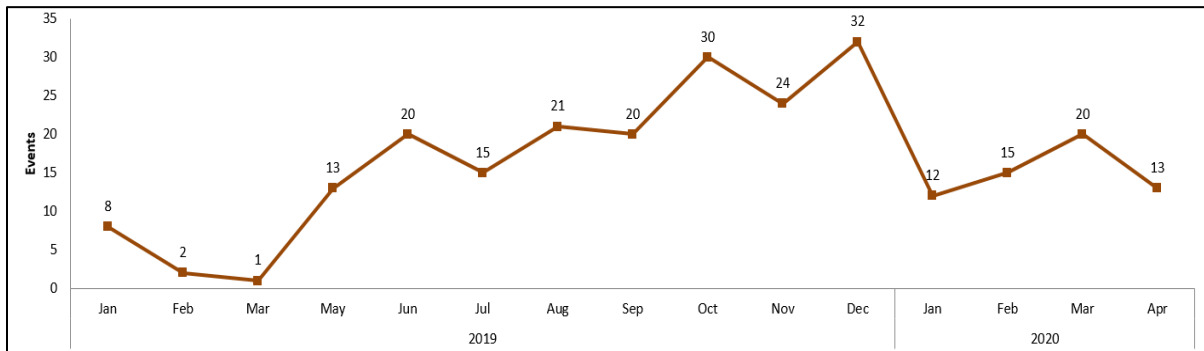
Figure 1: Tyres Replaced Per Month

The data in figure 1 shows the number of tyres replaced per month, the average tyre life for all failed tyres was 1100 hours as opposed to the projected 5000 hours. Figure 2 shows the machine monthly downtime due to tyre failures.

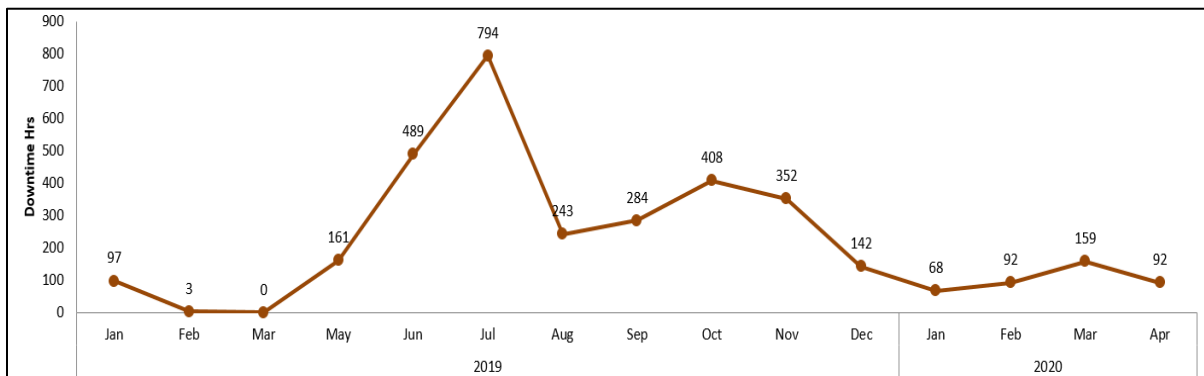
Figure 2: Tyre Downtime

The data in Figure 2 illustrates monthly tyre downtime for the failed tyres, June and July 2019 showed the highest downtime. The explanation to the extended downtime was that, this tyre size was new on the mine and both skills and tools were not adequate. Figure 3 shows tyre downtime against failure events.

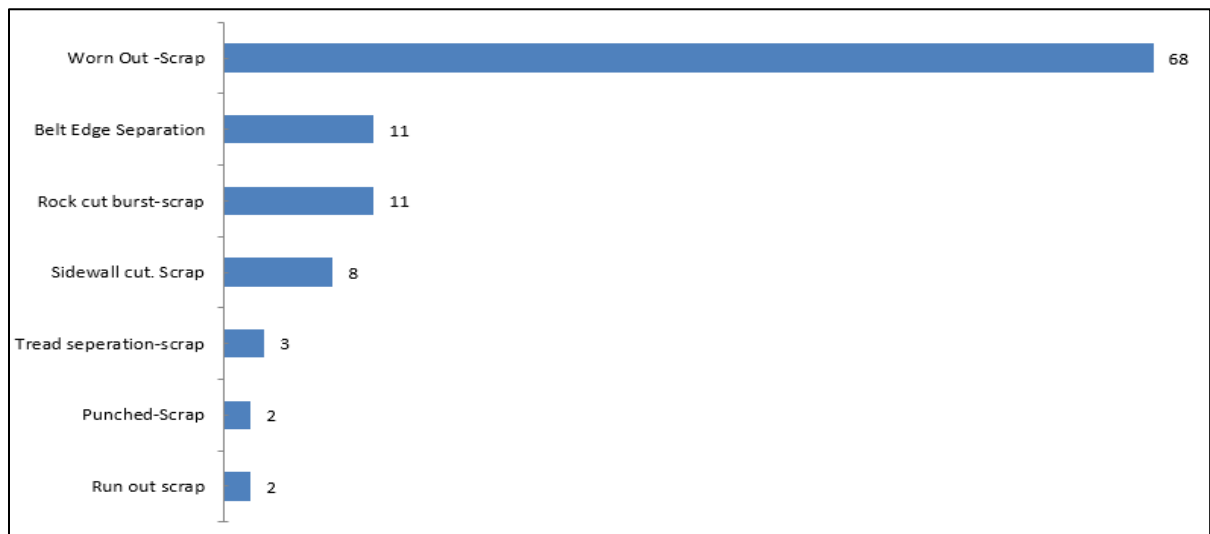
Figure 5: Tyre Failure Mode

Figure 5 shows the failure mode and occurrence, however, all the tyres during the period under review failed before the anticipated time. The average life for the tyres was 1100 hours whereas the projected life was 5000 hours. This implies only 22% of the tyre was used.

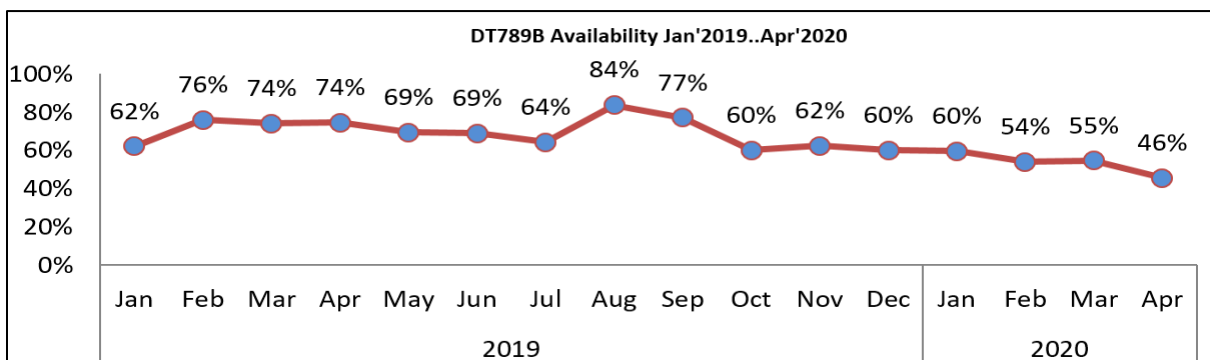
Figure 6: Equipment Availability

Generally, the machine reliability was low and this resulted into low utilization. The equipment had a number of other mechanical and electrical failures throughout the year from commissioning. Figure 7 shows other machine downtime causes.

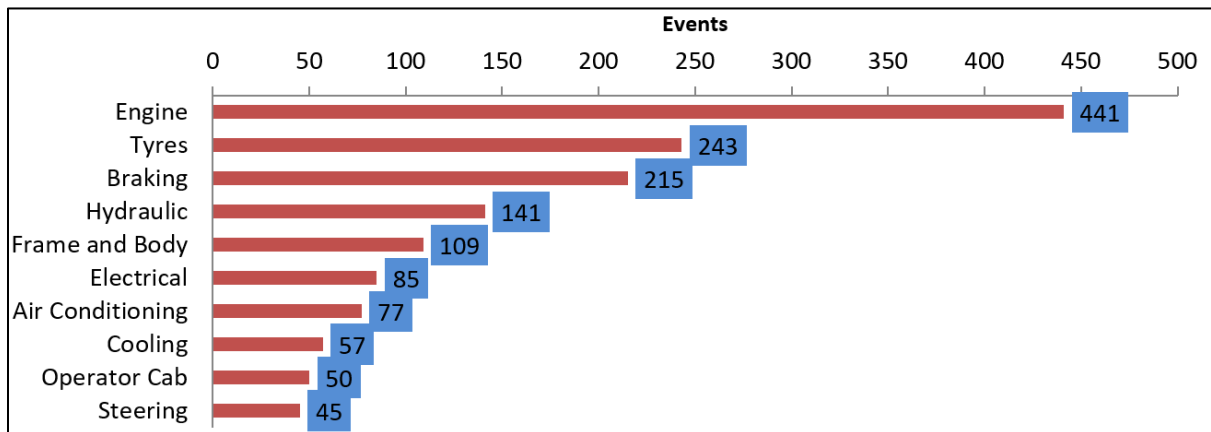
Figure 7: Machine Component Failure Mode

As seen from Figure 7, the equipment had several other failures that made the equipment unreliable and to operate less hours than planned. Figure 8 shows the monthly cumulative hours done.

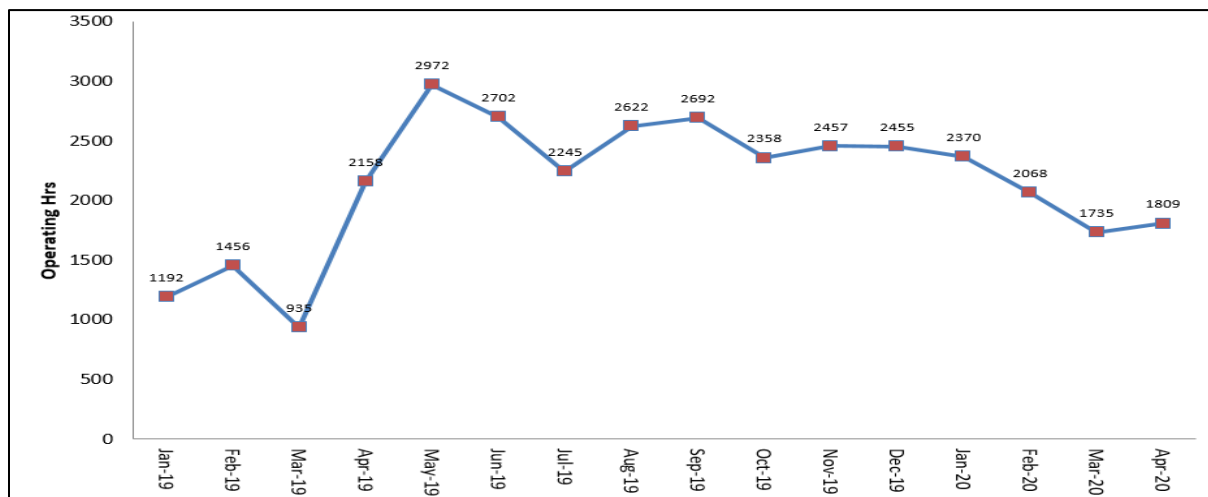
Figure 8: Dump Trucks Operated Hours.

The machines were expected to operate at 85% availability, however, the equipment could not meet this target due to breakdowns. Figure 9 shows the reliability measure of Meantime Between Failure (MTBF).

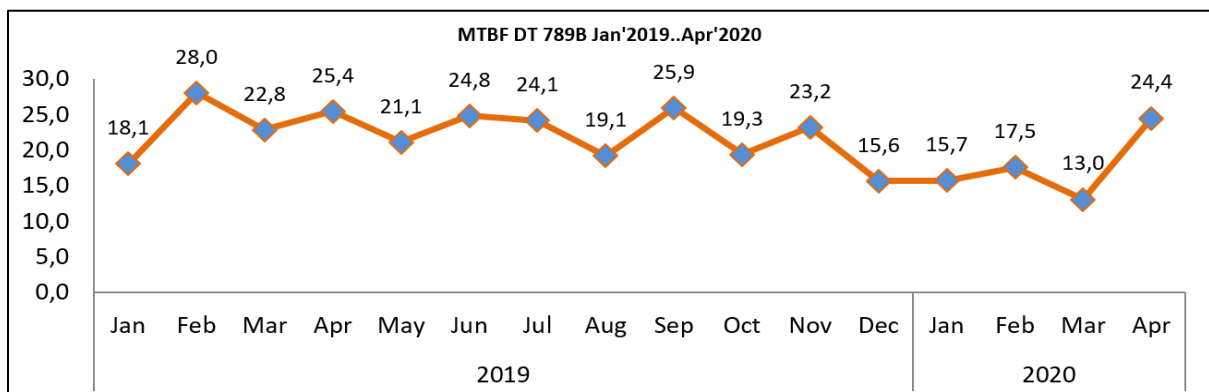
Figure 9: Meantime Between Failure

Though the Meantime Between Failure kept on declining, the tyre downtime did not take a declining trend, the failure rate was still high.
