Scenario of Urban Poor: Case Study of Addis Ketema (Woreda-07) in Addis Ababa City, Ethiopia

Abstract: The paper is addressing the scenario of urban poor in Addis Ketema (Woreda-07) of Addis Ababa city and common issue of the study area is inadequate of infrastructure facilities. The area of the Addis Ketema is 9863.9 hectare with a population of 28099 (CSA, 2013). Tool and techniques such as household survey, Focus Group Discussion (FGD) and field observation were adapted to investigate on the sectors of socio-economic, water supply, sewerage, drainage and solid waste management, and education. The following objectives were carried out - (1) to study the settlement pattern and socio-economic profile, (2) to study the physical facilities (water supply, sewerage, drainage, and solid waste management) and (3) to study the education system and performance. The result of this paper had reveals that Addis Ketema is pocket where poor people lives and per capita income is 50 Dollar approximately. Maximum numbers of people are running informal economic activities and suffering from inadequate municipal services.

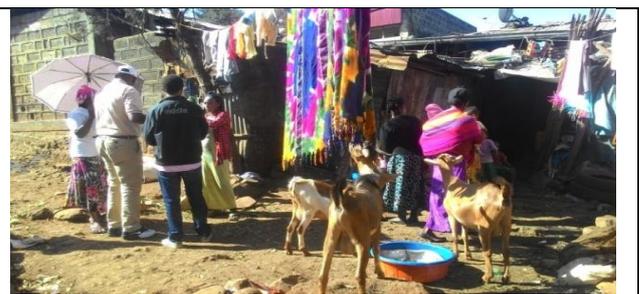
Fig. 4: Housing Condition, Picture Credit by Authors, 2015

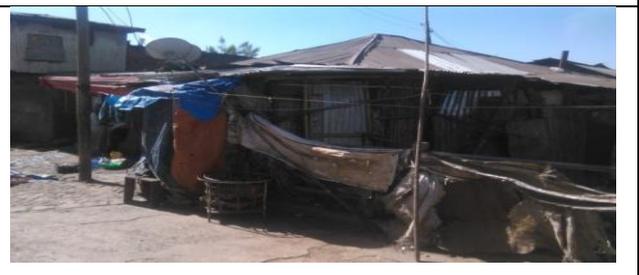
Fig. 6: House Type, Picture Credit by Authors, 2015

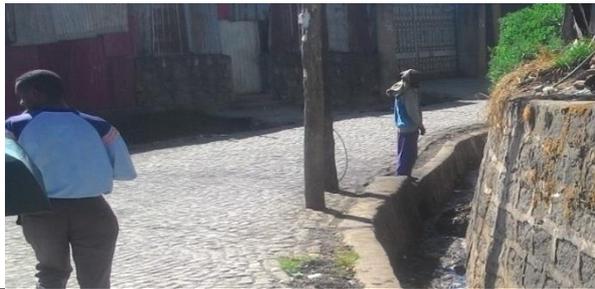
<p>Fig. 11: Open drainage, Picture Credit by Authors, 2015</p>	<p>Fig. 12: No Proper Drain, Picture Credit by Authors, 2015</p>

Drainage Scenario: The drain is divided into four categories namely; (i) open derange, (ii) closed drainage, (iii) semi-closed drain and (v) closed drain. Lack of operation and maintenance of the existing drains is a common issue (Fig. 11, 12, 13). Open drains are filled by solid waste and block the flow of water during rainy season since drainages used as dumping by common people (Fig.14). Almost 30 of the entire area are partially semi-closed (Fig. 15, 16). During the rainy season, it fully floods and water logging is common issues. Even the diseases are occurring and also negative impact on social life and day to day activities. There is some area within the Addis Ketema (Woreda -07) which is partially covered with closed drain (Fig.18).

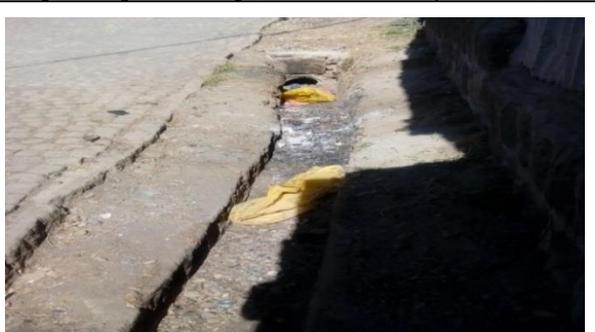
<p>Fig.13: Open Drain, Picture Credit By Authors, 2015</p>	<p>Fig. 14: Open Drain Fill up with Solid Waste, Picture Credit By Author, 2015</p>

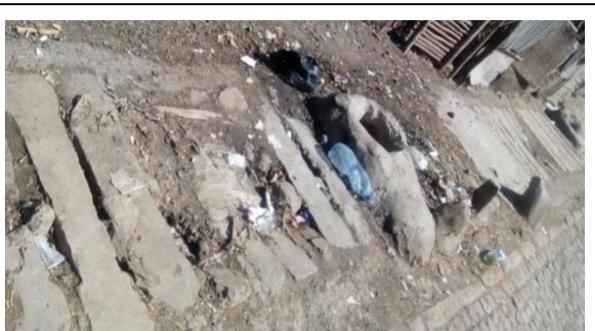
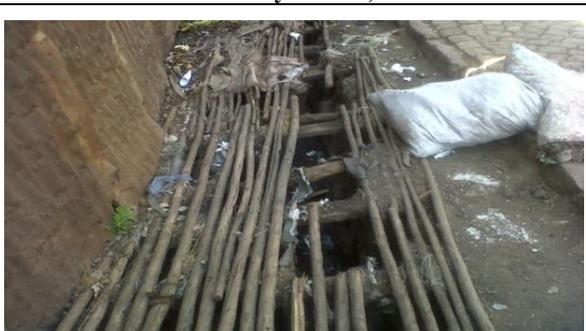
<p>Fig. 15: Semi-Closed Drain, Picture Credit by Authors, 2015</p>	<p>Fig. 16: Semi-Closed Drain, Picture Credit By Authors, 2015</p>

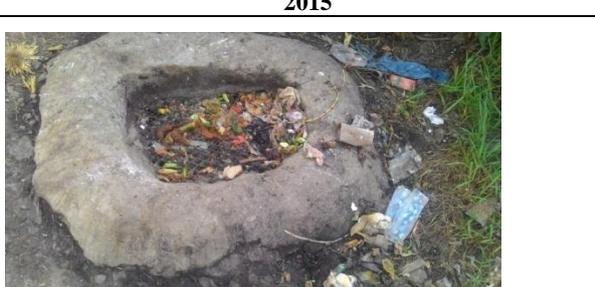
<p>Fig.17: Solid Waste Practice System, Picture Credit by Authors, 2015</p>	<p>Fig.18: Closed Drain, Picture Credit by Authors, 2015</p>

Solid Waste Management: The Woreda-07 has generating the solid waste an approximately of 5500 kg per day as on 2015 (AKEO, (2015). The components of the solid waste generating are vegetable waste, plastic bottle, plastic bags and wood etc. There is no proper system of solid waste for collection, transportation and dumping and further process etc. The collection and transportation is inefficient and no scientific system. Collection points for solid waste are absence in an around the Woreda -07. The current practice for solid waste is dumping into the open areas and even fills up into the low laying areas. Based on the Household survey data reveals that solid waste generated from dwellers is being collected
